# HURRICANE RISK OF MULTI-FAMILY DWELLINGS IN PUERTO RICO

**Peter L. Datin**

*Risk Management Solutions, Inc., 7575 Gateway Blvd., Newark, CA, USA, peter.datin@rms.com,  
<http://www.rms.com>*

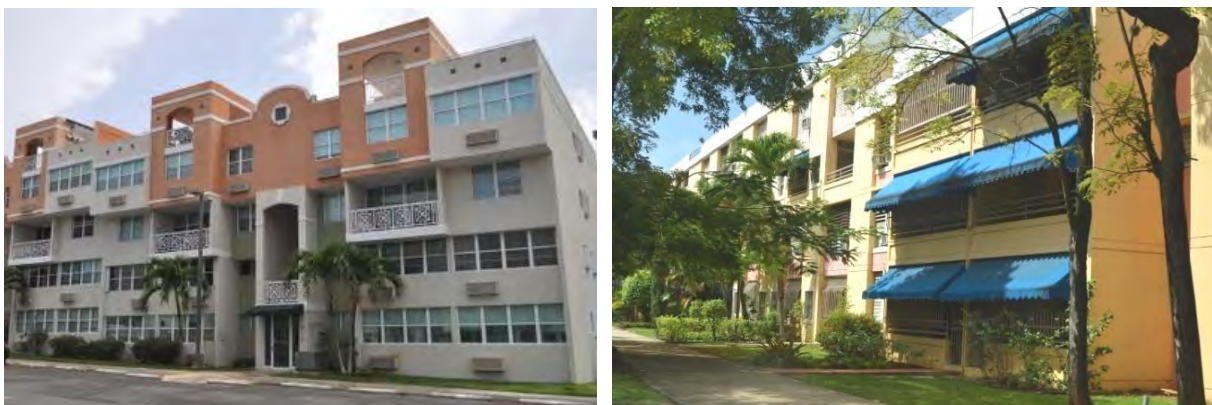
Figure 2: Typical "walk-up" multi-family dwellings in Puerto Rico

In Puerto Rico, multi-family dwellings with 2-4 stories are referred to as "walk-ups" because there are no elevators and occupants use stairs to access the upper floors. [Figure 2](#) shows a typical "walk-up" in San Juan, Puerto Rico.

Walk-up buildings primarily use reinforced concrete shear walls to resist lateral loads. Moment-resisting frames are almost never used and were not observed in the field. Interior walls are constructed using reinforced concrete masonry blocks (CMU). Gypsum partitions are not used in walk-ups because they are more expensive than masonry and because there is

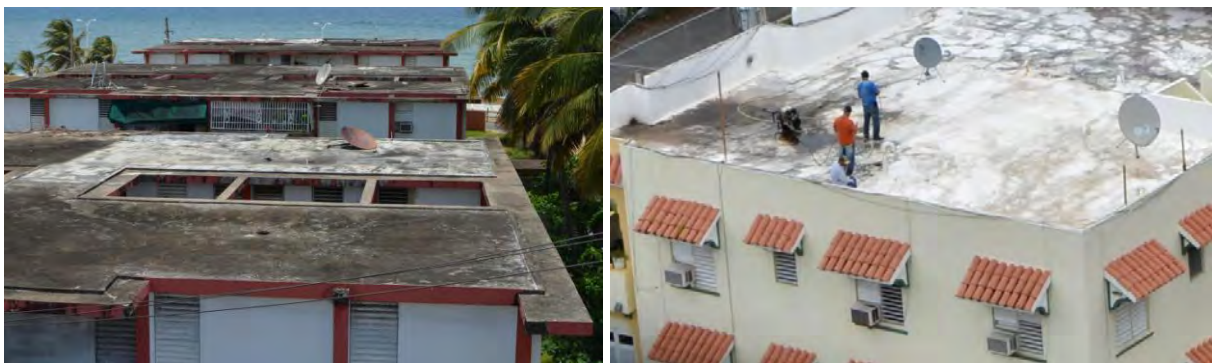
The roofs are reinforced concrete decks that are generally five to six inches thick. They are essentially flat with a minimal slope for water drainage (Figure 3). Most roofs are covered with either paint or a chemical that combines with the concrete to prevent leakage. When a built-up roof cover is used, the cover is a thermoplastic polyolefin (TPO) membrane or something similar. Gravel is almost never used on the roofs of MFD buildings, even when the roof cover is built-up. Parapets are also common and generally range from a few inches to four feet in height.

Figure 3: Typical reinforced concrete roof deck

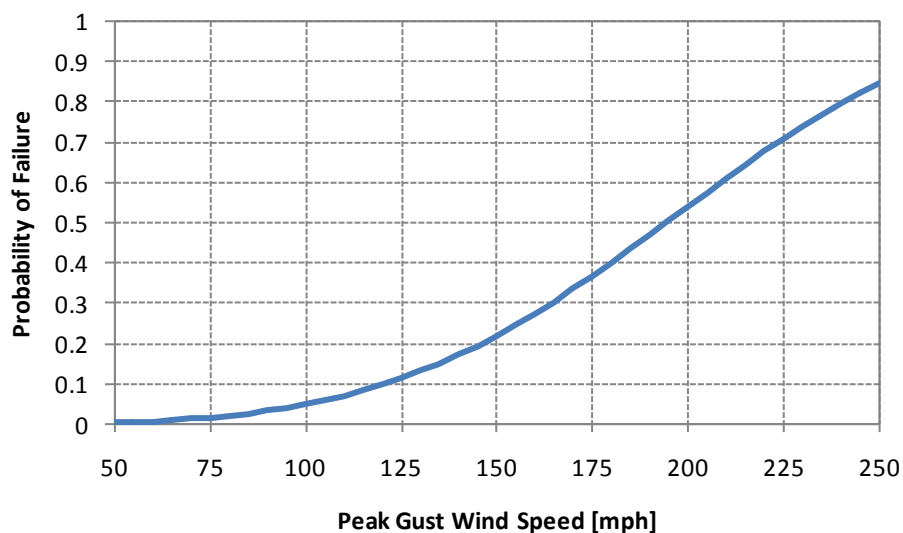
A building component simulation tool has been developed to aid in determining the vulnerability of various components based on the wind loads and the component resistances. Wind loads are calculated from wind tunnel studies on simple rectangular buildings representative of walk-ups in Puerto Rico. The major components considered in the analysis include windows, wall coverings (i.e. stucco), roof cover, and external ornamentation (i.e., fences, window awnings, etc.). The loads on the windows include both wind pressure and windborne debris. A sample fragility function for a window is shown in Figure 4. From these fragility functions, a mean damage ratio can be determined based on the average cost to repair or replace these components and the probability of failure of each component. This method also accounts for the probability distribution of the wind loads (i.e., pressures) and windborne debris at a given wind speed.

Figure 4: Sample fragility function for windows
